DOE/NASA/0008-12
NASA CR-165139

CERAMIC REGENERATOR SYSTEMS
DEVELOPMENT PROGRAM — FINAL REPORT

C. A. Fucinari, C. J. Rahnke, V. D. N. Rao, J. K. Vallance
Research Staff
Ford Motor Co.

Prepared for
National Aeronautics and Space Administration
Lewis Research Center
Cleveland, Ohio 44135
Under Contract DEN 3-8

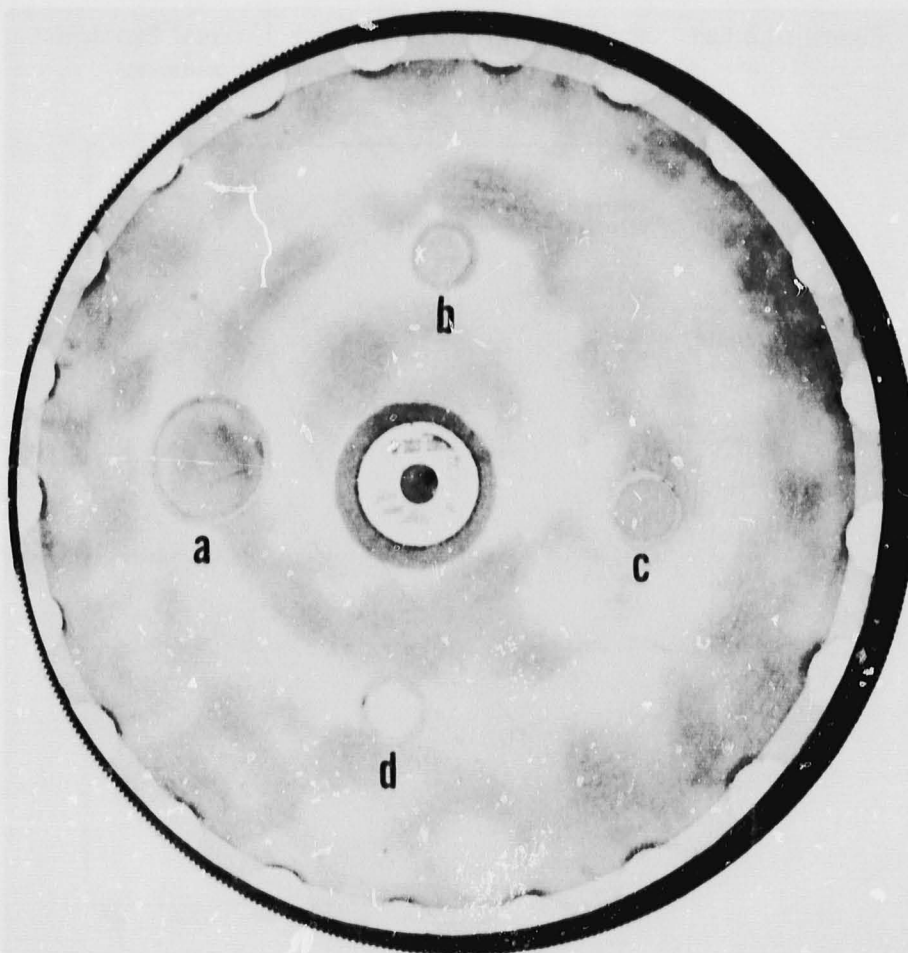
Figure III.B.2.1 Accelerated Corrosion Test Core 1 with Matrix Inserts

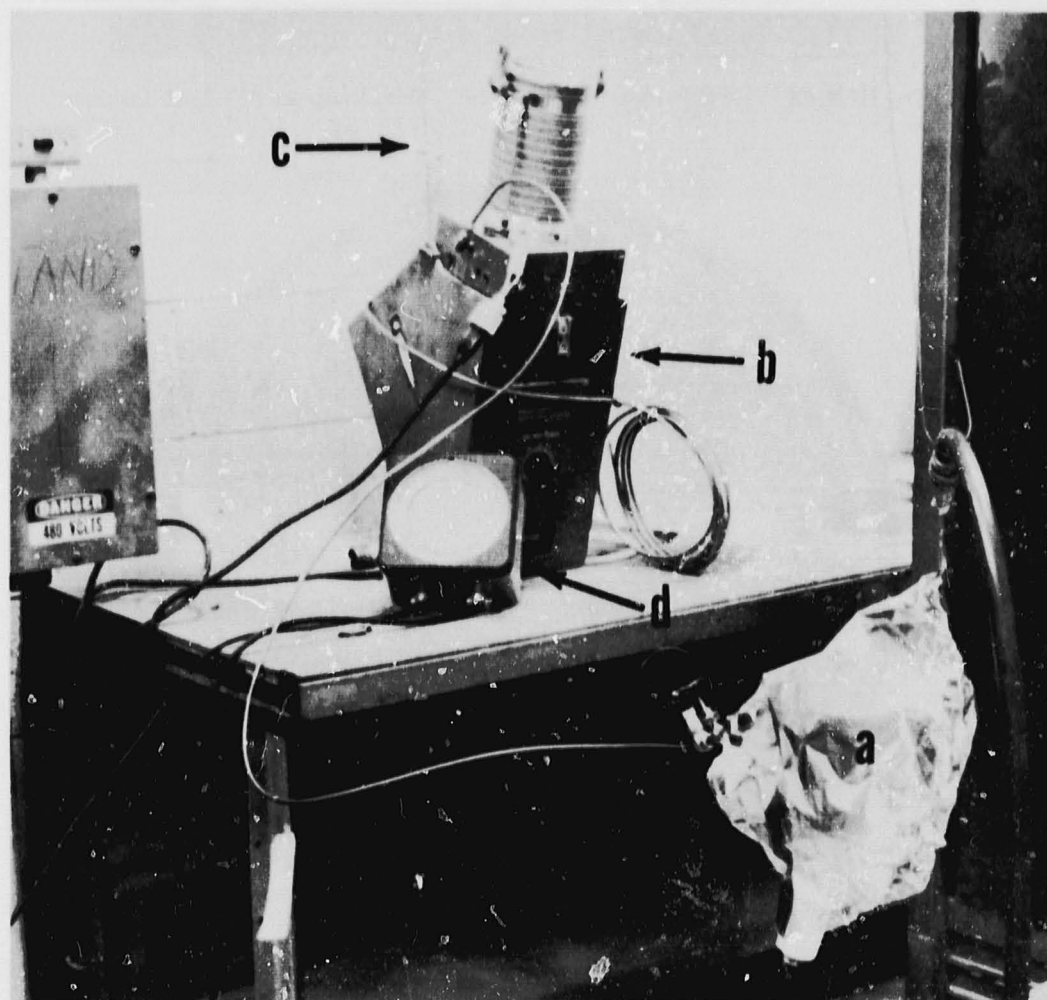
Figure III.B.2.2 Salt Ingestion System — Measurement and Transportation

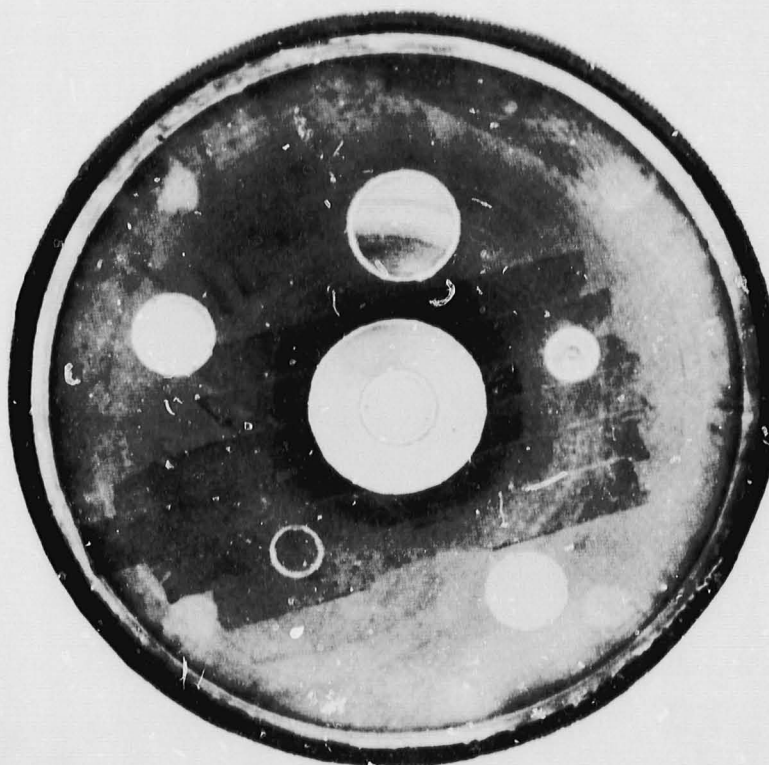
Figure III.B.2.4 Test Core-2 Accelerated Corrosion Leached LAS Host Matrix with Matrix Inserts for Accelerated Corrosion Testing

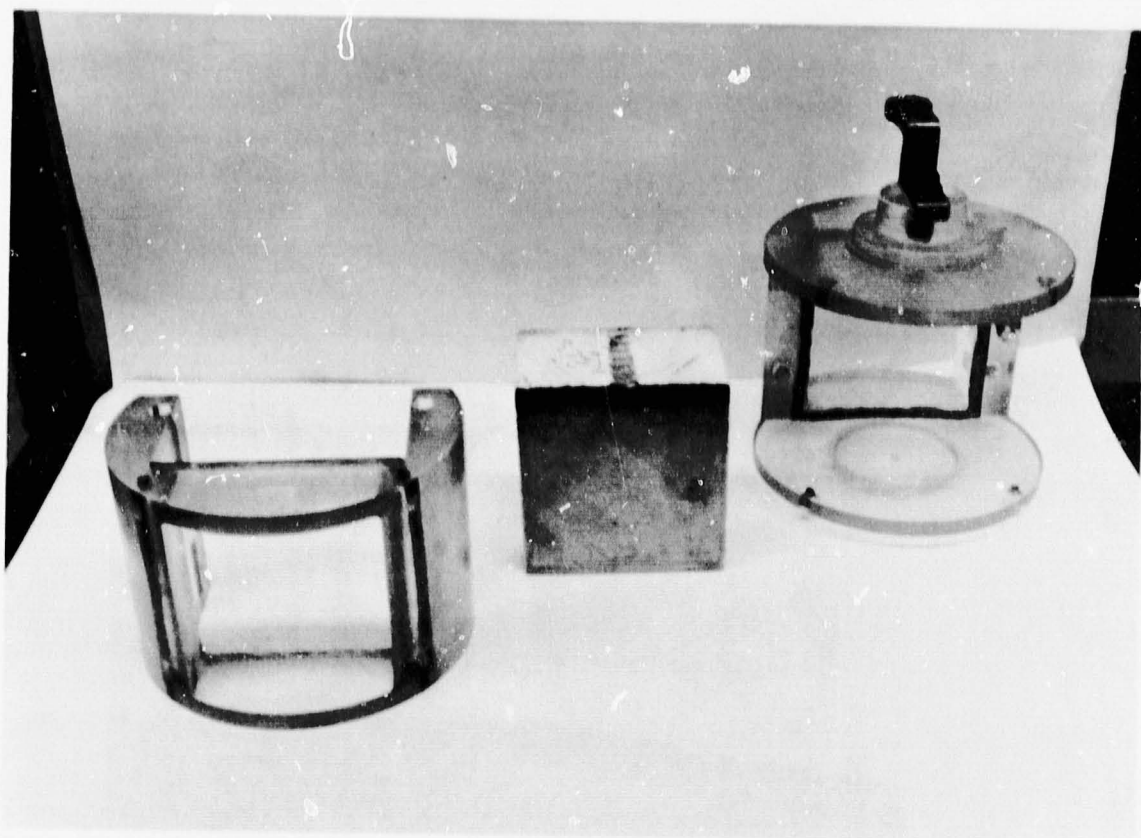
Figure IV.A.3 Photograph of Inner Cylinder Used in the Shuttle Rig

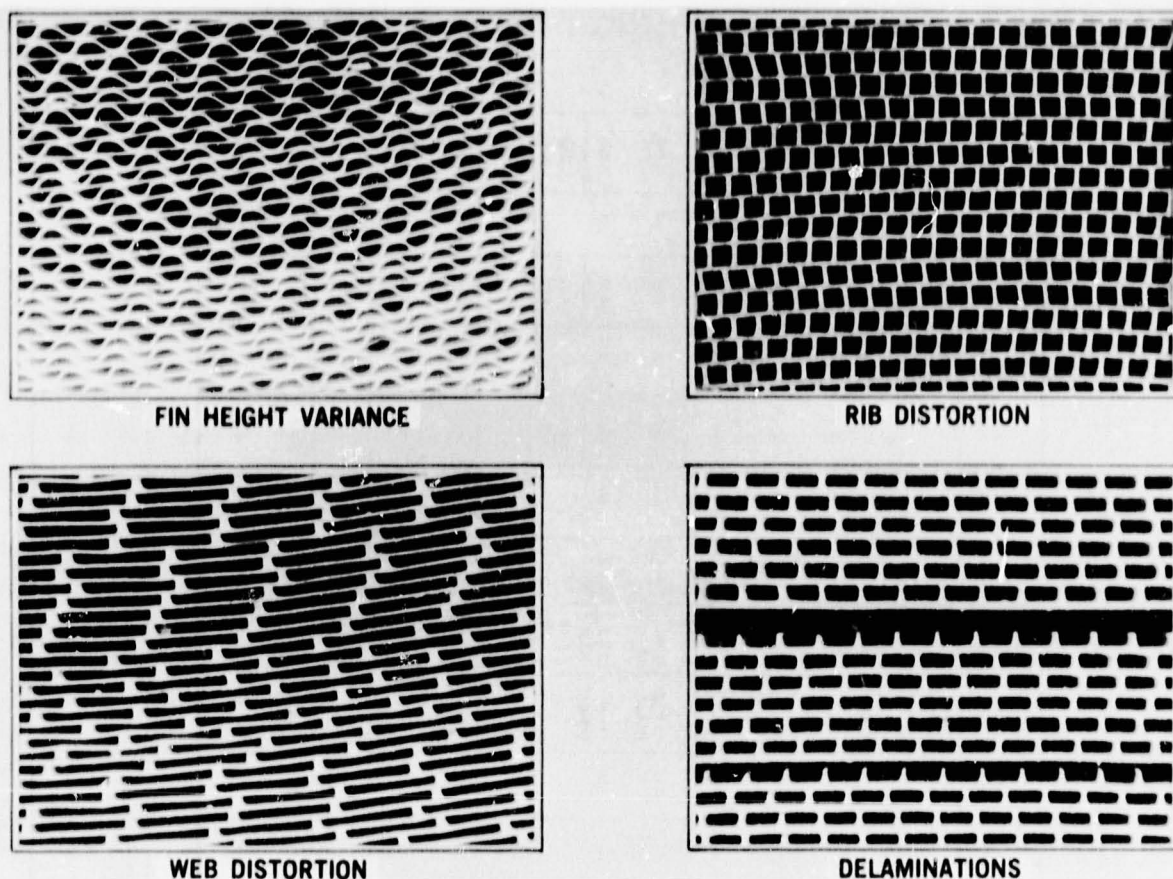
Figure IV.B.2.1 Photographs Illustrating Manufacturing Defects

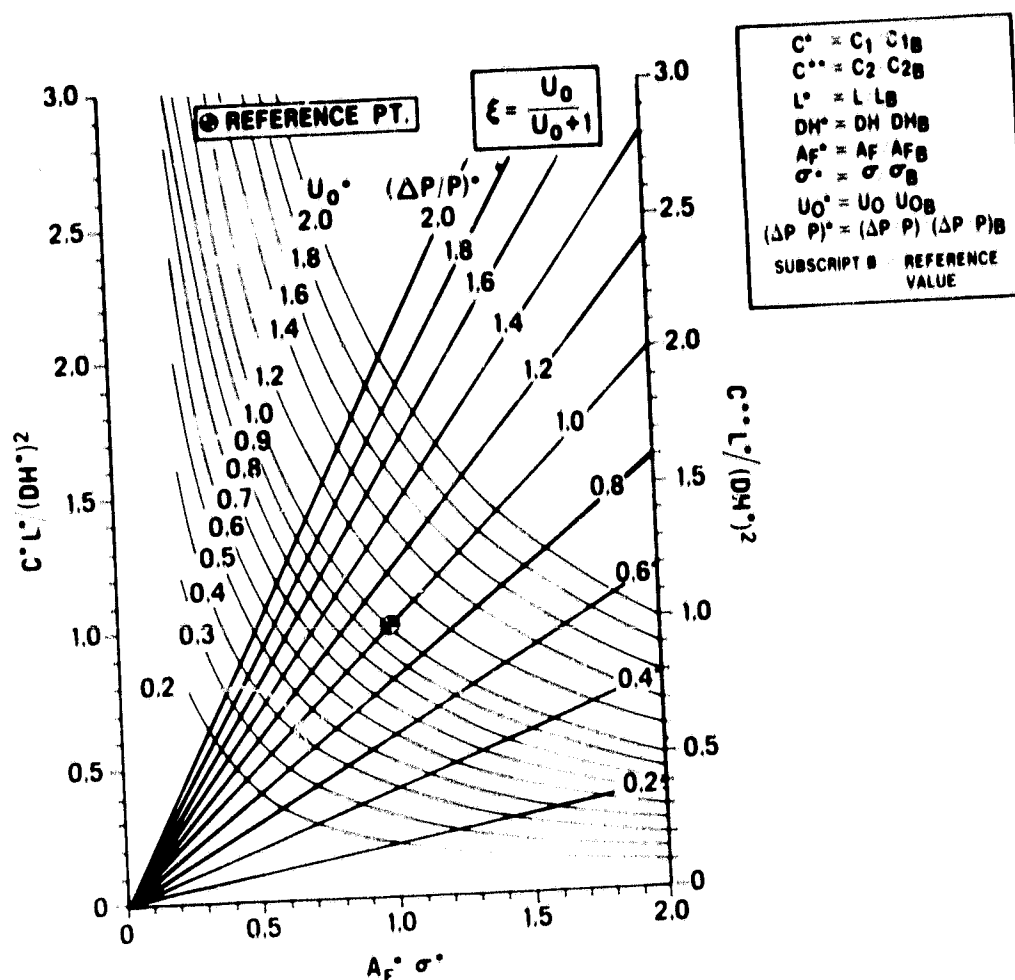
Figure IV.B.3.1 Parametric Curves for Heat Exchanger Thermodynamic Performance

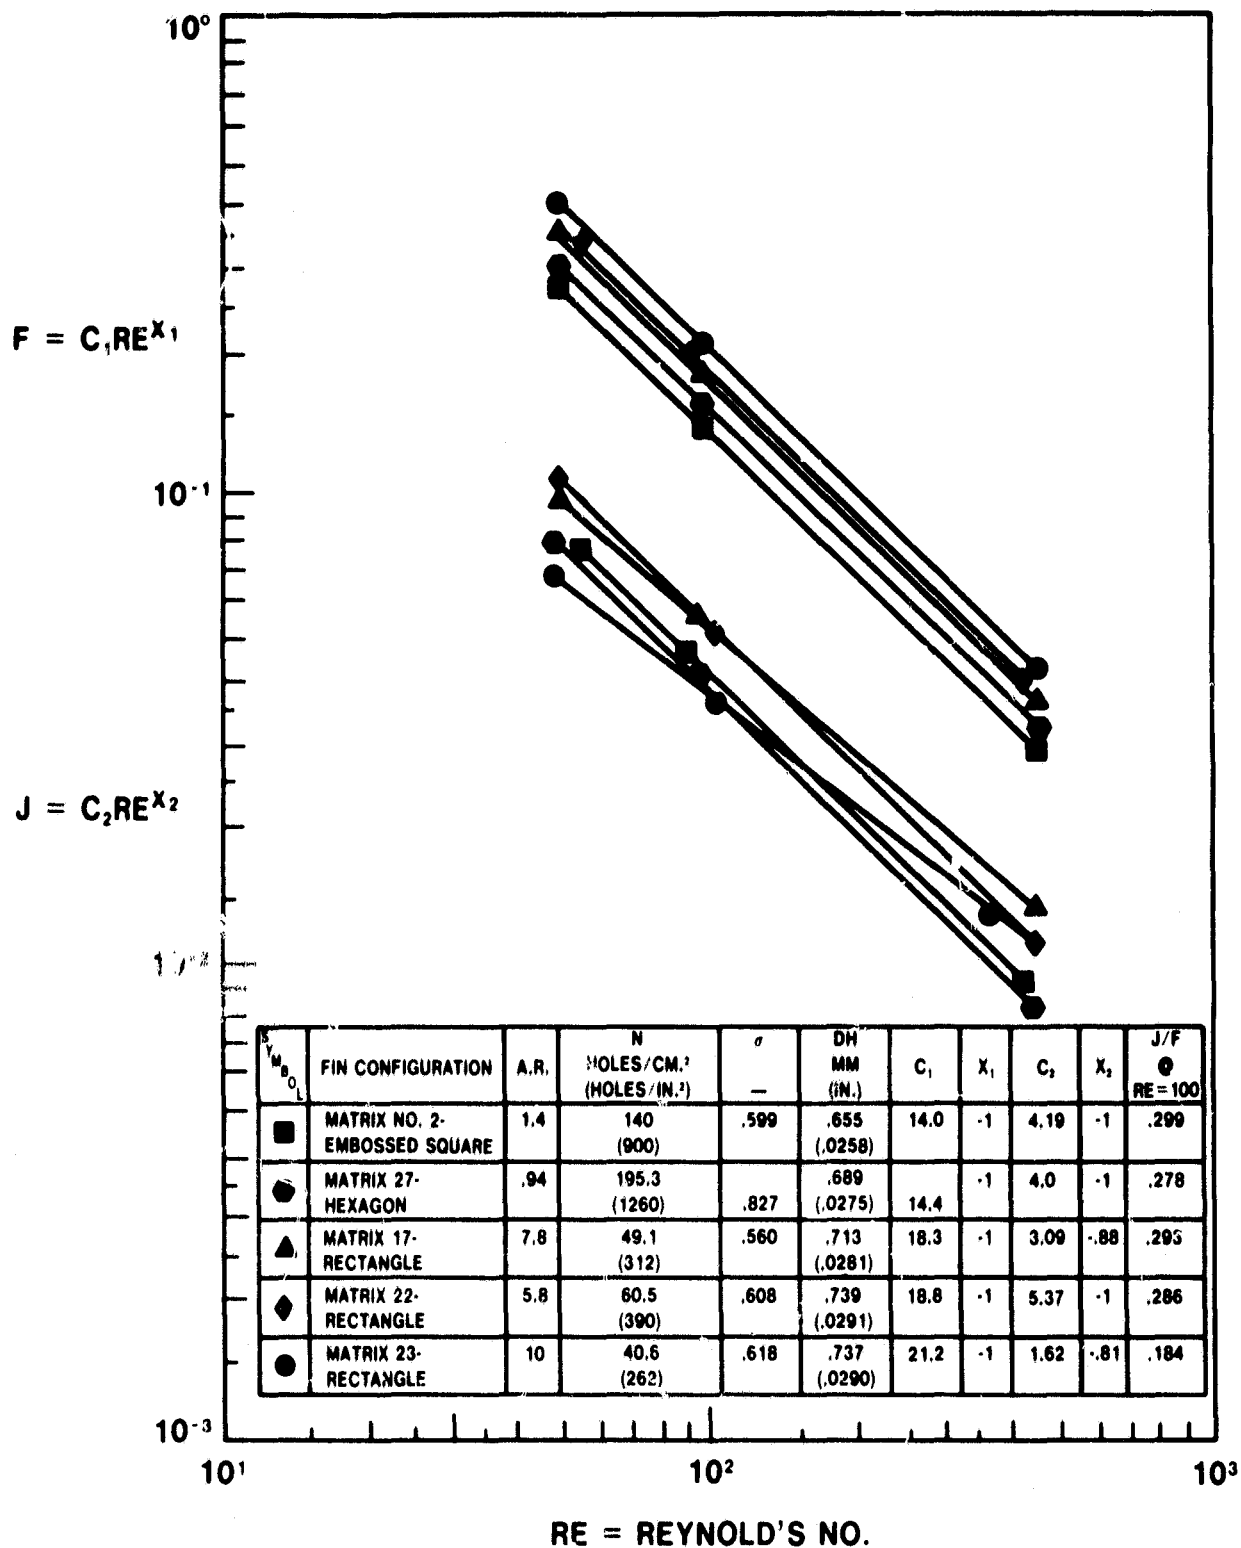
Figure IV.B.3.4 Standard Thermodynamic Performance Characteristics for Matrices 2, 17, 22, 23 and 27

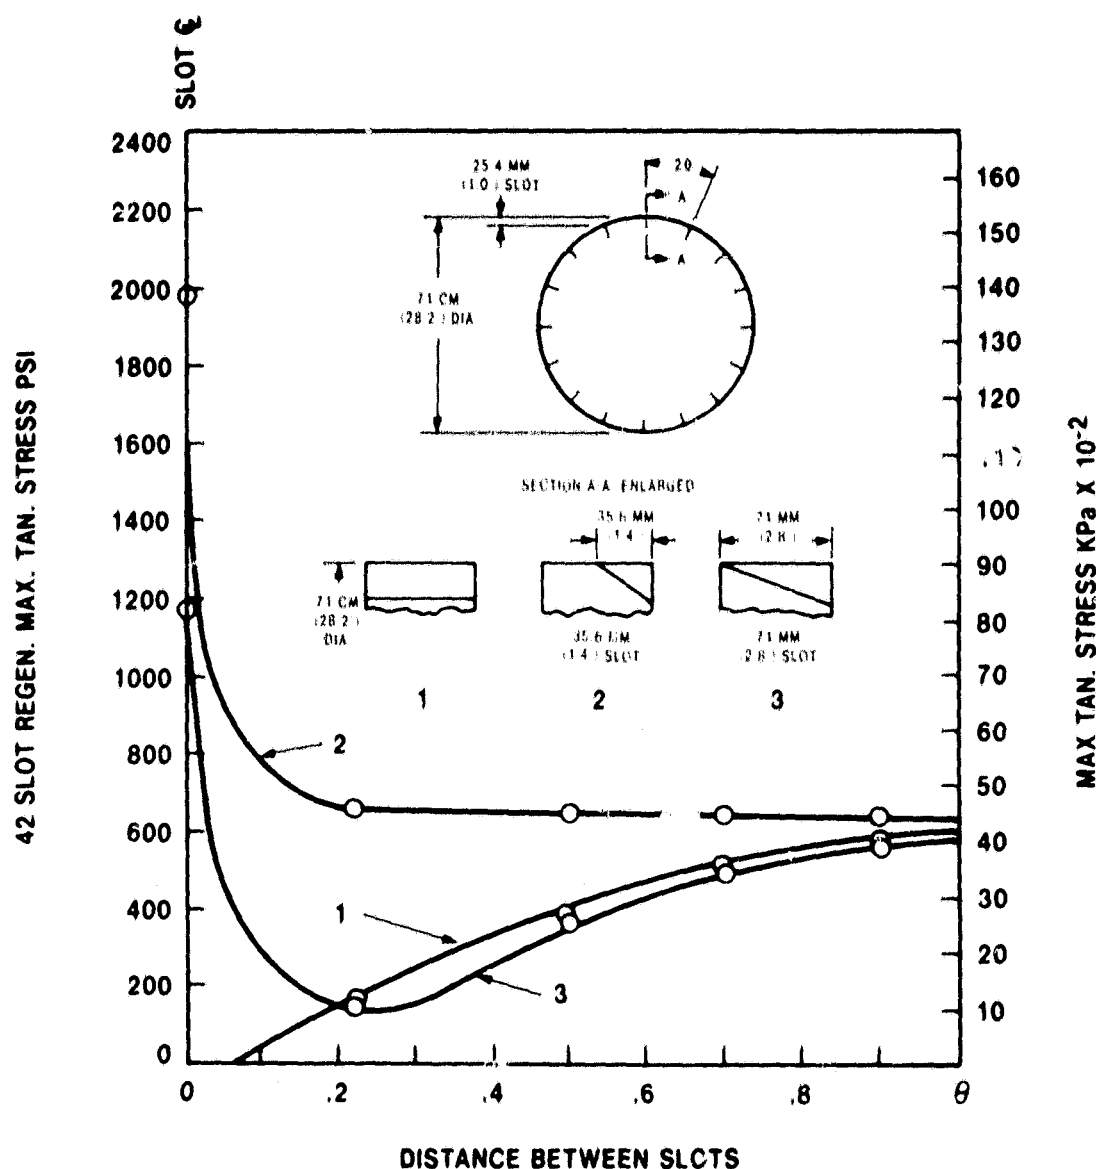
Figure V.B.2.7 Distribution of Tangential Stress in Supplier D MAS-2 Regenerator at 1000°C (1832°F)

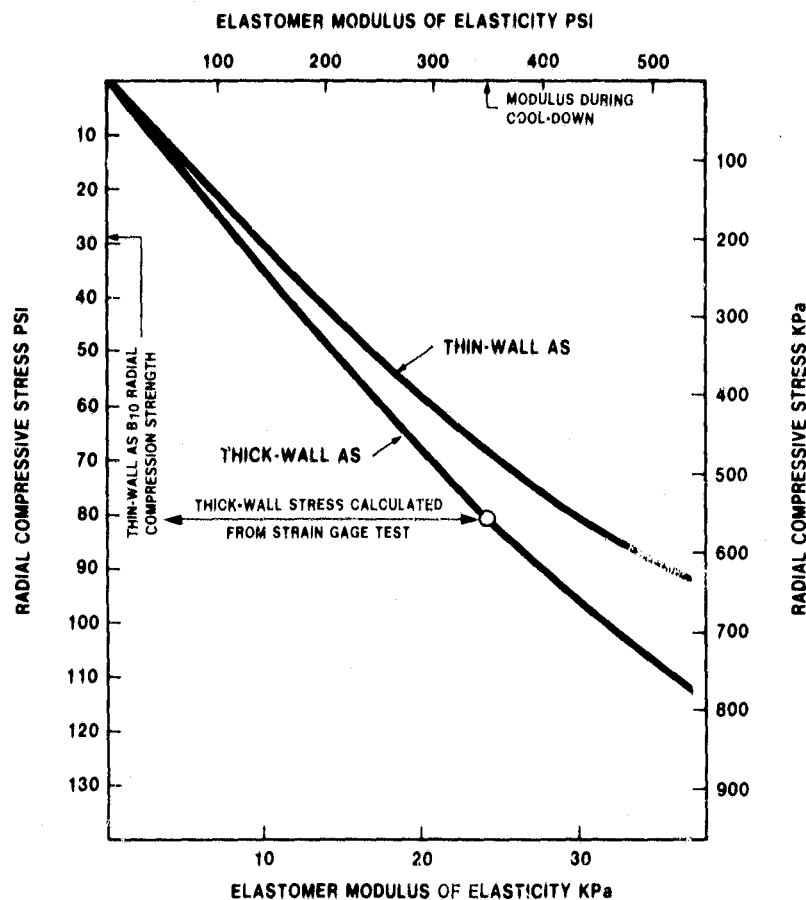
Figure V.B.3.2 Radial Compressive Stress Vs. Apparent Elastomer Modulus of Elasticity During Bonding

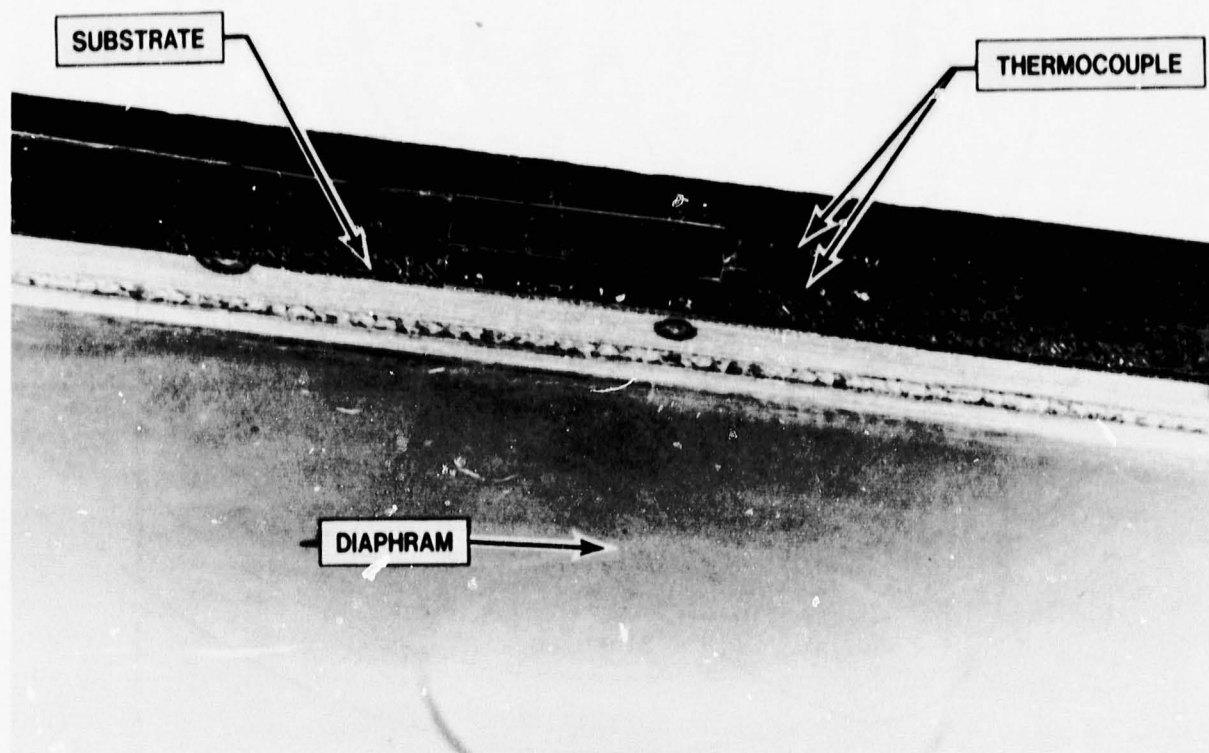
Figure V.B.4.1 Crossarm Seal Probe Mounting Location

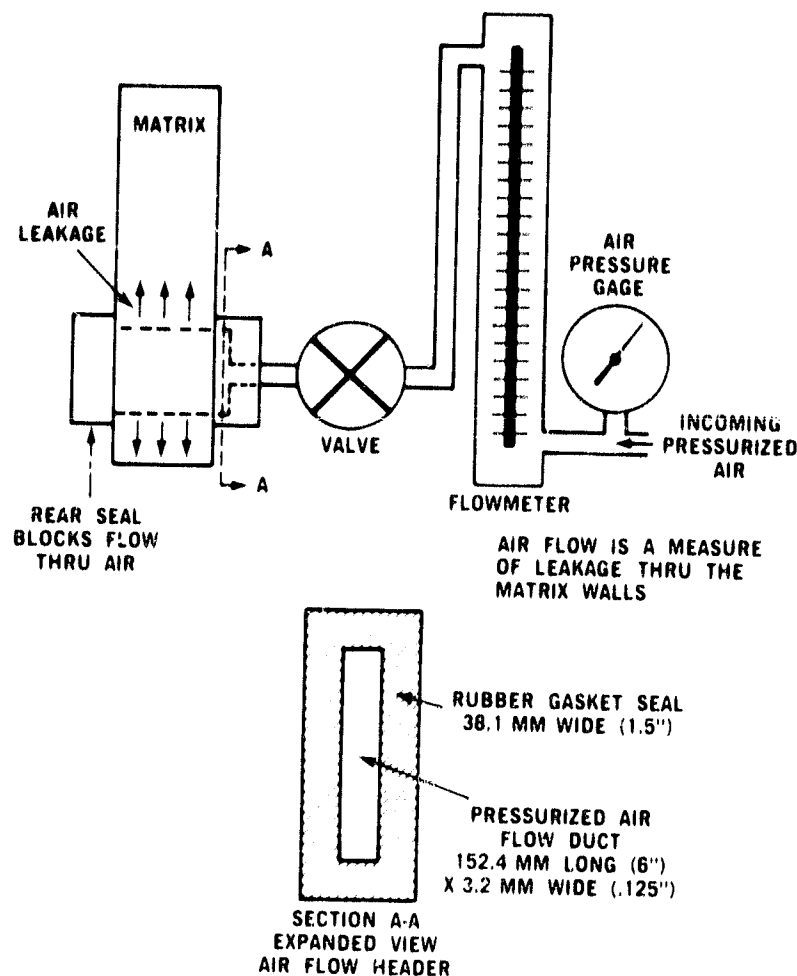
Figure VIII.B.1.1 Schematic of Matrix Wall Leakage Measurement Device

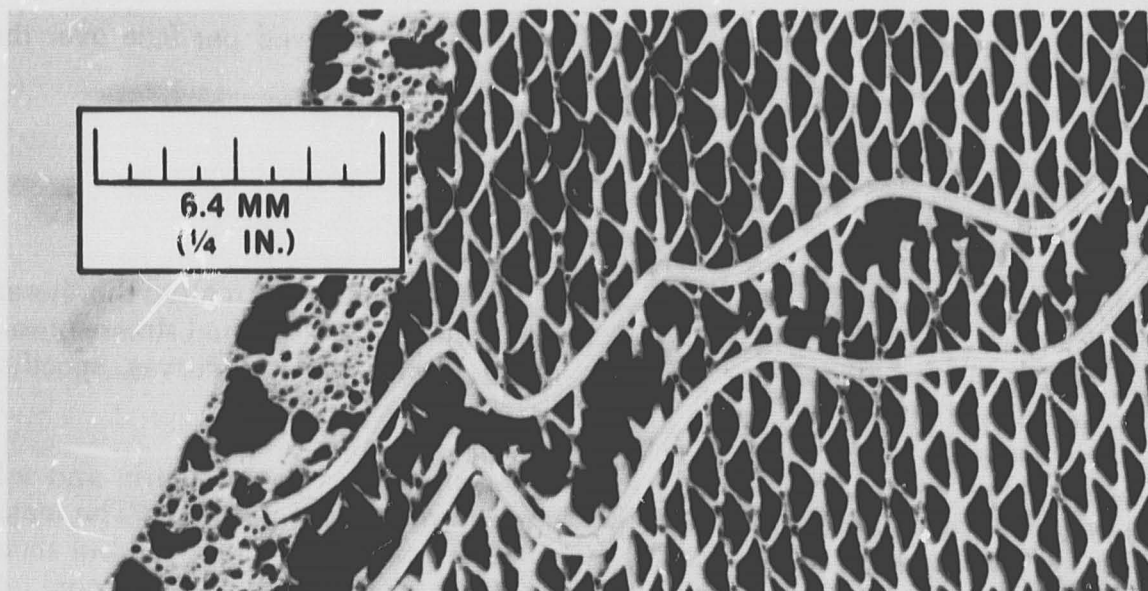
Figure VIII.B.1.6 Matrix Photograph Showing a Long Radial Crack near the Solid Hub
